Manhole Inspection Summary

Manhole # S47I2_023MH

Location Address: **4810 Curtis Ave** Cross Street: **Cherry-Church Alley**

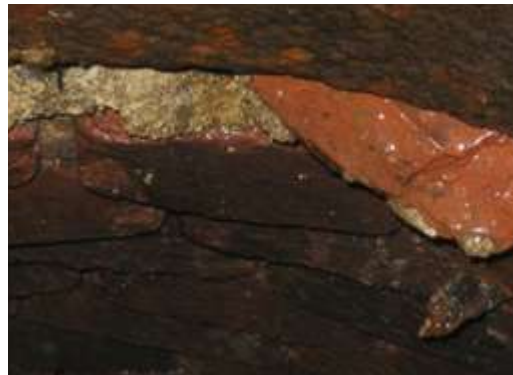
Defect 2

Chimney / Frame Adjustment ☒ Exists Material: **Brick** ☐ Parged Height: **14** (in.)
Condition: ☐ Sound ☐ Cracked ☐ Root Intrusion ☒ **Loose Brick** ☐ Deteriorated
Infiltration: ☒ None ☐ Joint ☐ Cracks ☐ Mortar ☐ Roots ☐ Wall

loose brick on chimney

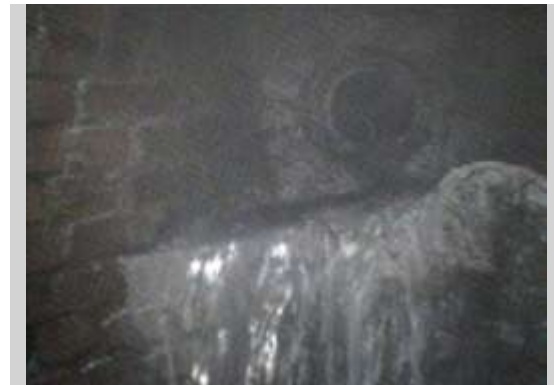
3 O'Clock Inflow

8 in. Circular Gravity Sewer
Pipe In @ 3 O'Clock

Pipe Height: **8.4** (in.) Rod and Bar (Angled)
Pipe Material: **Clay** ☐ Pipe Lined
Invert Depth: **6.06** (ft.) Flow Characteristics: **Fast**
Deposits: ☒ None ☐ Mud ☐ Sludge ☐ Debris ☐ Grease
Silt Depth: (in.) Deposits Extent:
Infiltration: **None** Pipe Seal Cond: **Sound**

Drop: **Inside** Rod and Bar
Angled: **Yes** Reading: **11.34** (ft.)
Inv Depth: **12.34** (ft.)

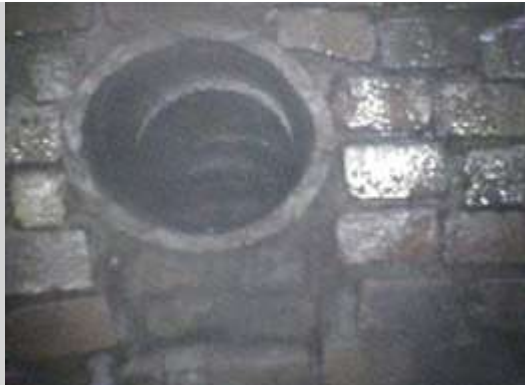
9 O'Clock Inflow

6 in. Circular Service Sewer
Pipe In @ 9 O'Clock

Invert Depth: **5.15** (ft.) Flow Characteristics: **Fast**

Infiltration: **None**

Pipe Seal Cond: **Sound**
